**iSPECT**  
BUILDING INSPECTIONS

## New Building Inspection Report - Completion Stage

Type of Report: New Building Inspection - Completion Stage

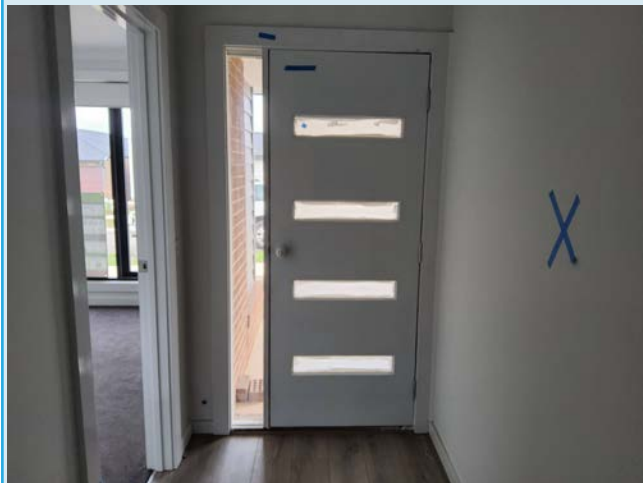
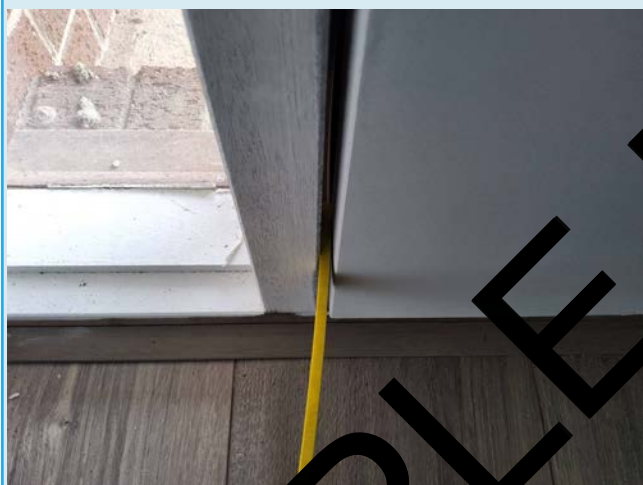
Entry, it has been observed that the door margins appear to be tight and irregular, less than 2 mm and exceeding 2 mm.

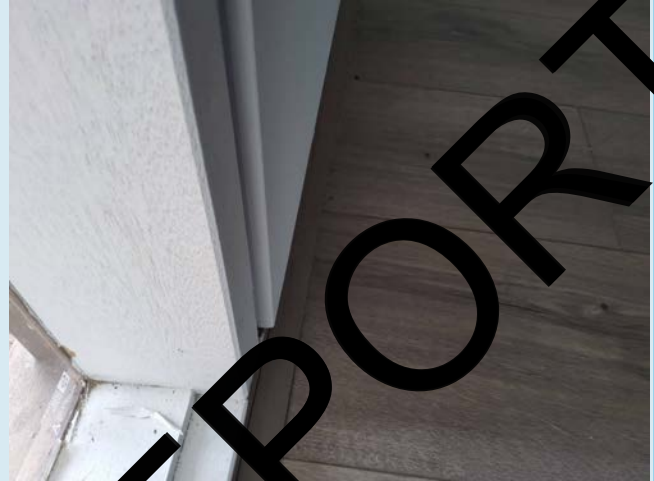
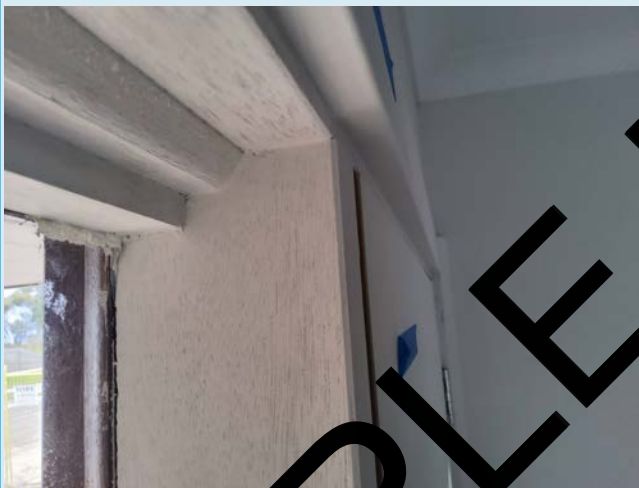
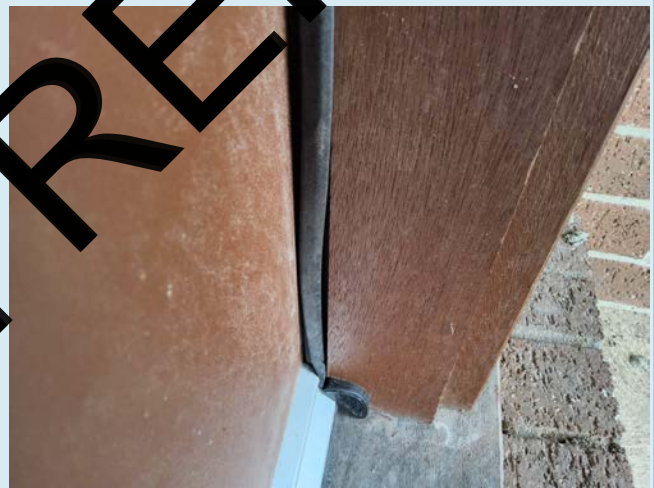
Entry, it has been observed that the door appears to require adjustment, the door does not sit flush with the door jamb, nor does the bottom of the door sit tight up against the draught seal.

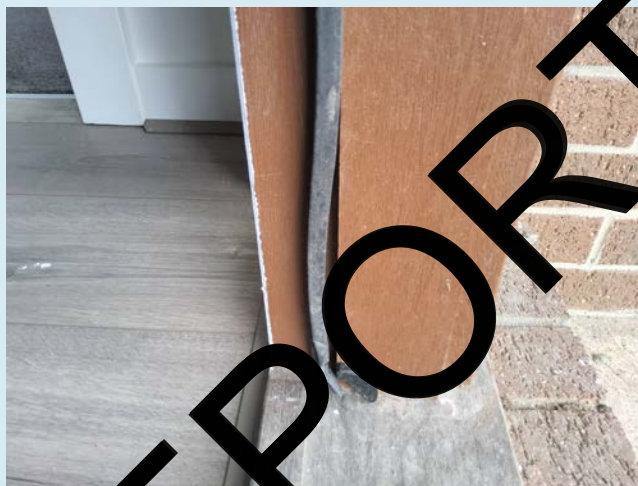
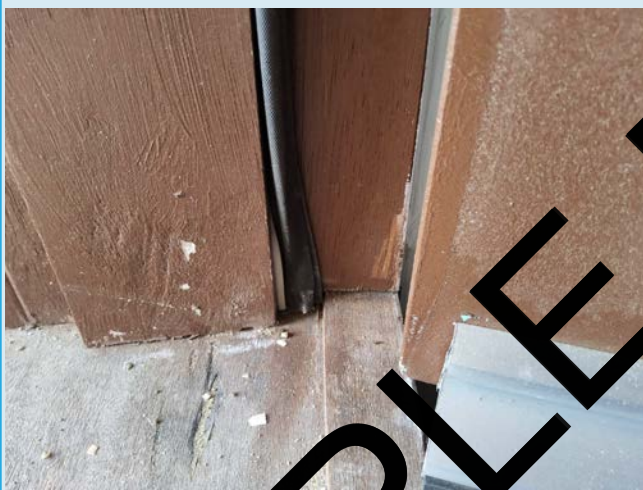
Entry, it has been observed that the bottom sections of the draught seals appear not to be fitted adequately to the door jamb.

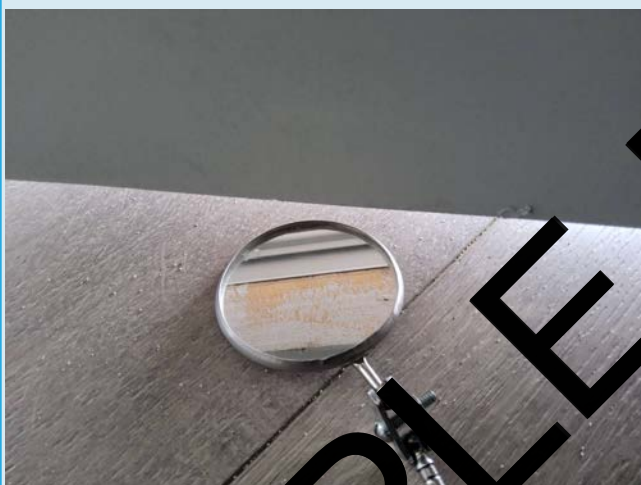
Entry, it has been observed that the top and bottom edges of the door have not been adequately painted/seal.

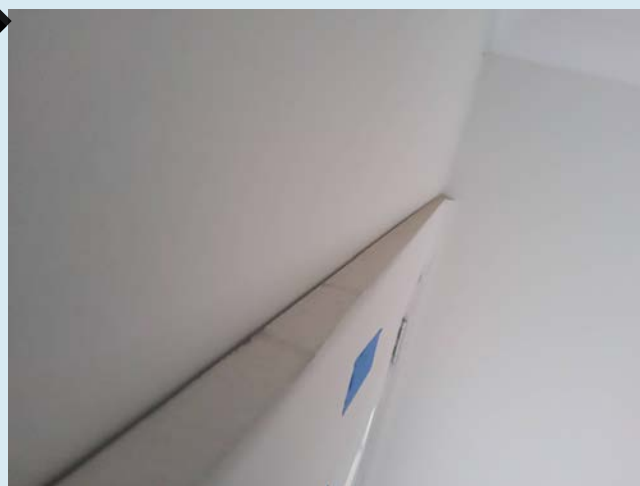
Check throughout, it is noted that there appears to be gaps to the top and bottom of the doors and windows, the associated gaps may effect the six star energy rating and cause loss of amenity if not sealed adequately.

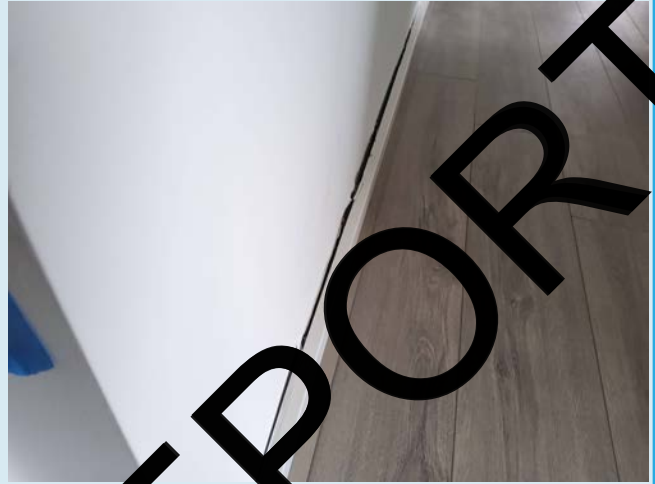
Passage leading to the kitchen, left elevation, it has been observed that the wall appears to be bowed.

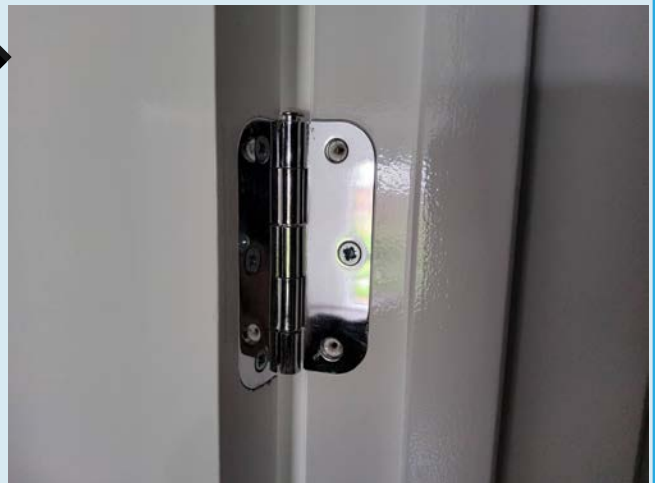
Linen/broom cupboard, it has been observed that there appear to be hinge screws missing to the top left hand side hinge.

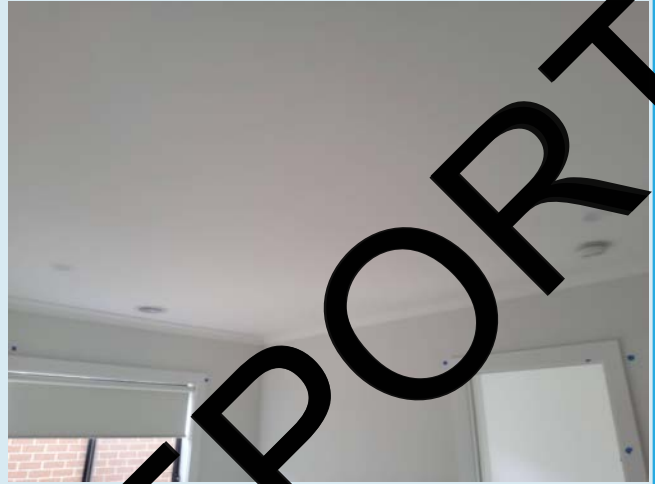
It has been observed that there appears to be no power supply to the back section of the house.

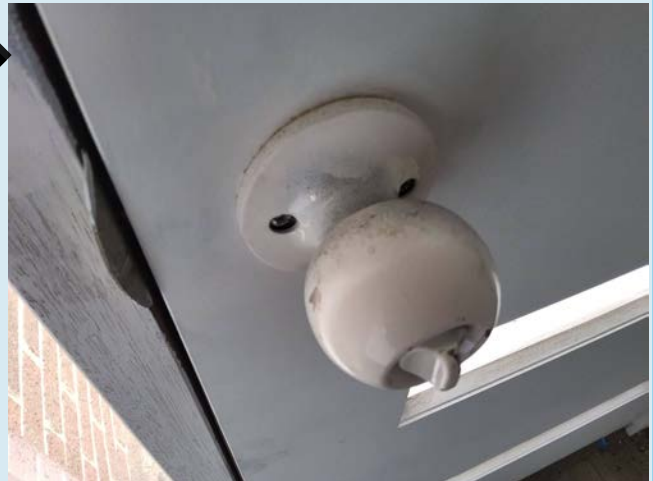
Entry, it has been observed that there appears to be paint on the door handle that will lead to be cleaned off.

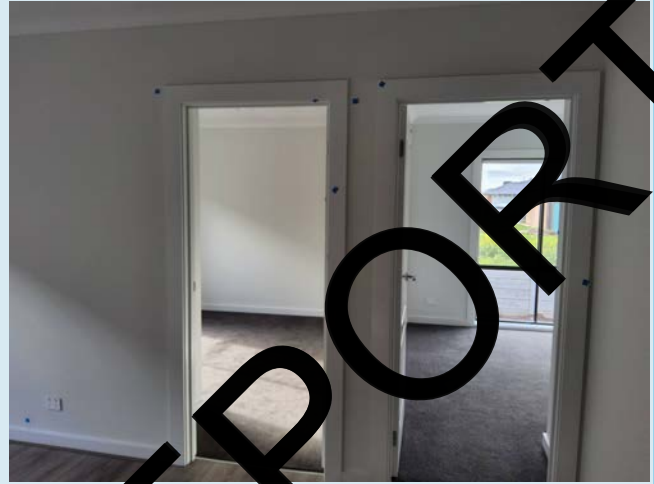
General note, check throughout, paint touch ups required throughout.

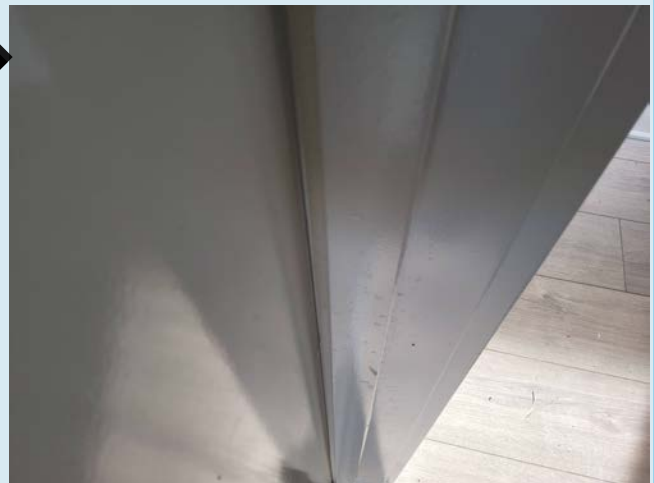
Garage, internal access door, it has been observed that the face of the door appears not to sit flush with the draught seal.

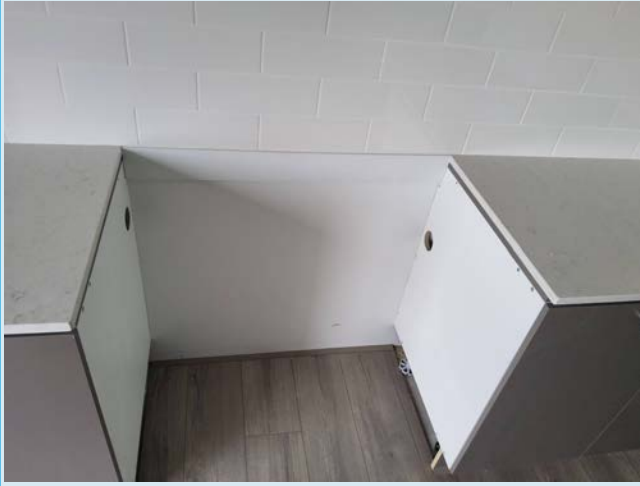
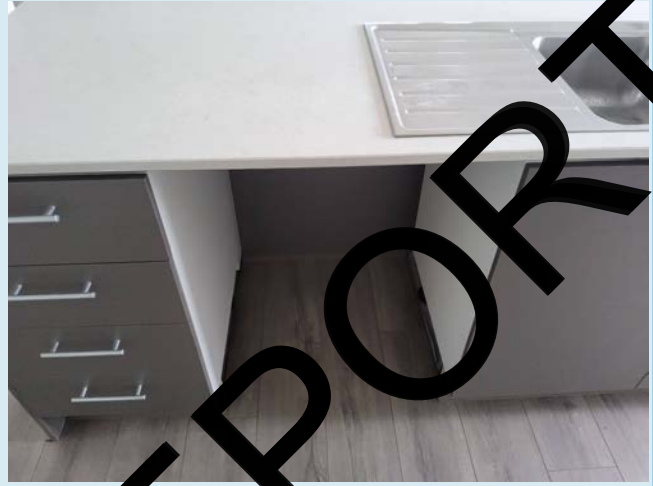
Kitchen	
Incomplete Item	Appliances ( Oven, Range Hood, Dishwasher)
<b>Comments</b>	
It has been observed that the appliances were not yet installed at the time of the inspection.

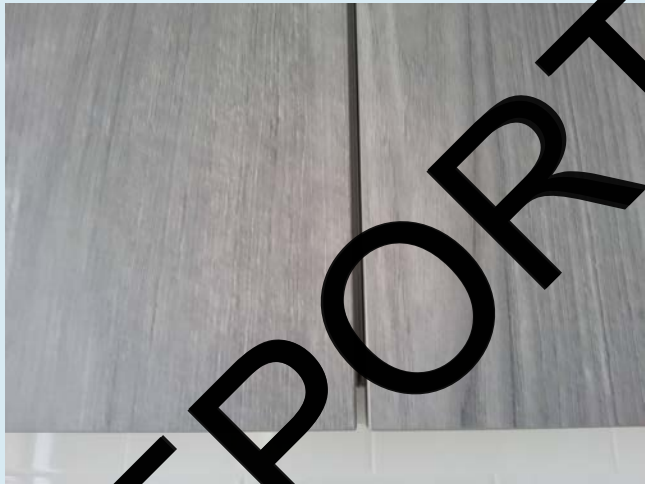
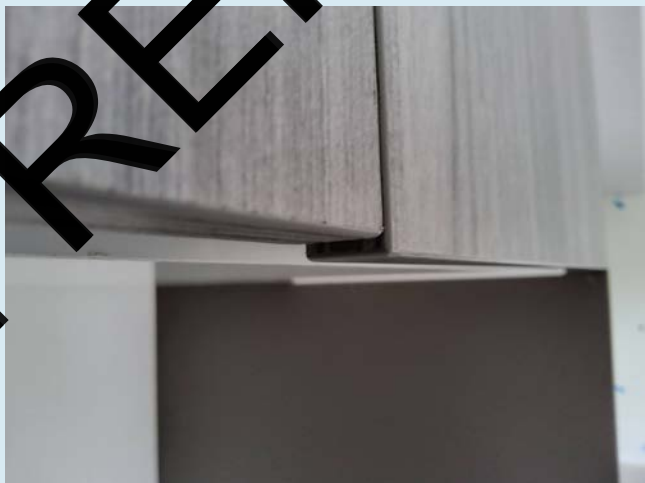
Kitchen	
Minor and/or Major Defect	Cabinets / Drawers
<b>Comments</b>	
It has been observed that the cabinet doors appear not to align to various areas, also the margins appear to be tight and irregular, check throughout.

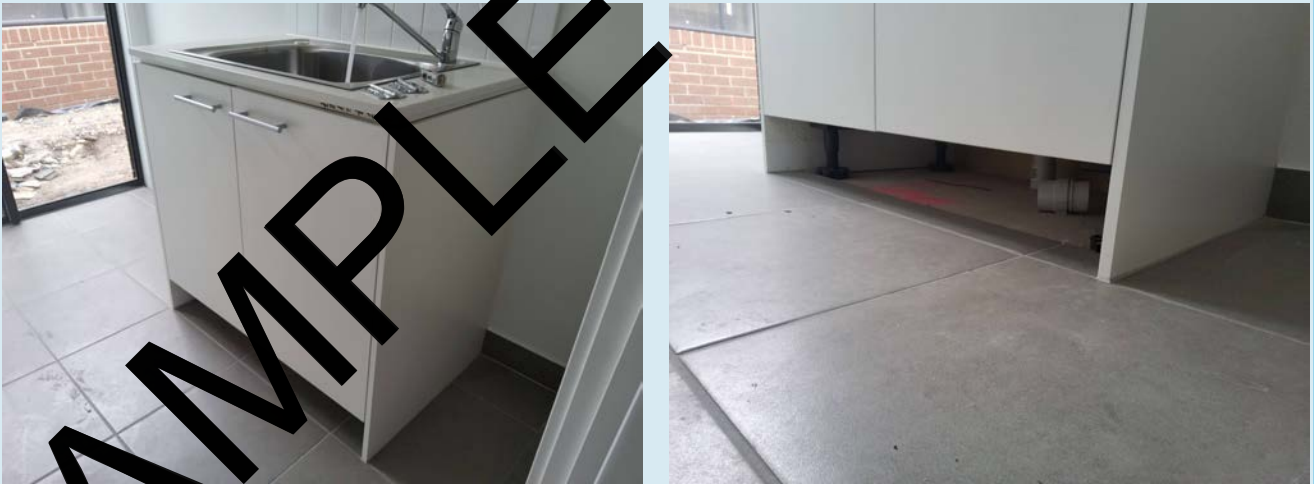
Laundry	
Minor and/or Major Defect	Cabinets
<b>Comments</b>	
It has been observed that the kick board to the bottom of the cabinet was not yet installed at the time of the inspection.

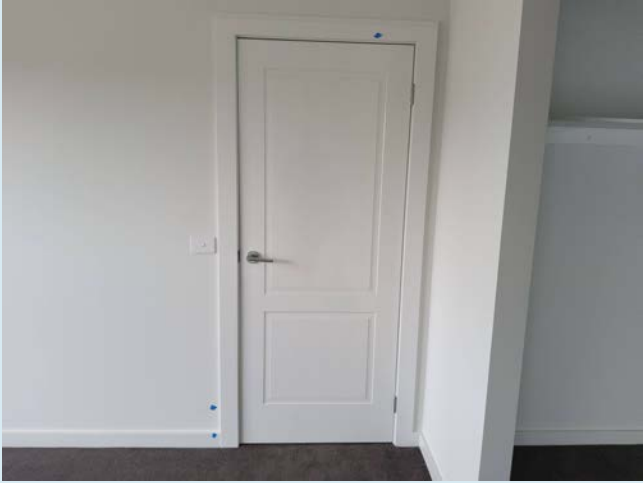
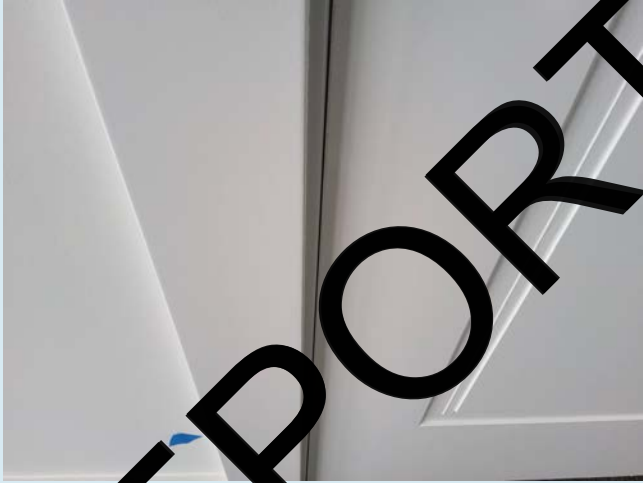
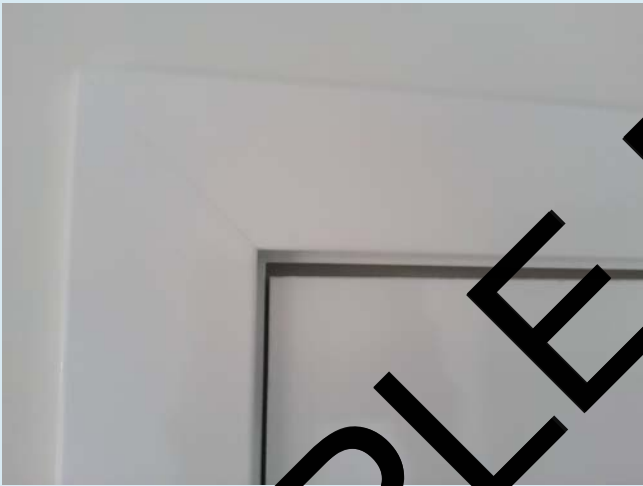
Bedroom 1	
Minor and/or Major Defect	Doors
Comments	
It has been observed that the door margins appear to be retired and irregular.

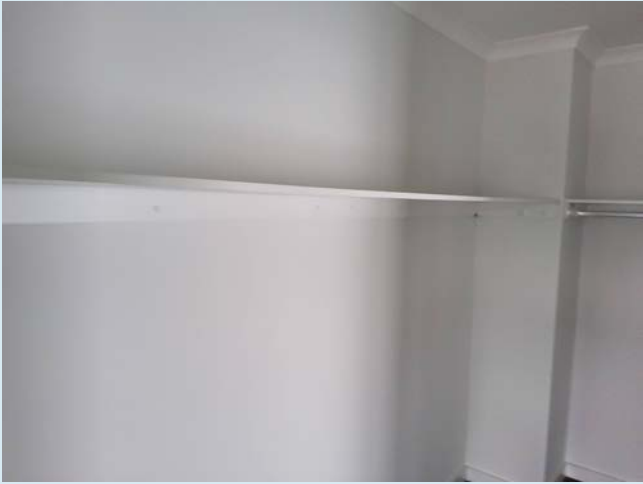
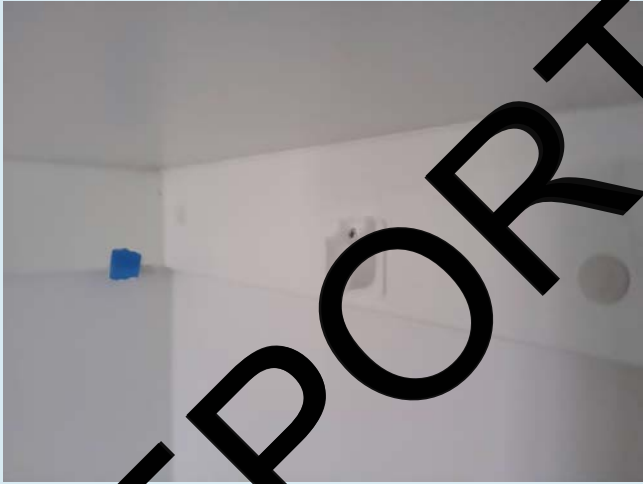
<b>Bedroom 1</b>	
<b>Minor and/or Major Defect</b>	<b>Robes</b>
<b>Comments</b>	
It has been observed that the hanging rail and shelf support appeared to be missing.

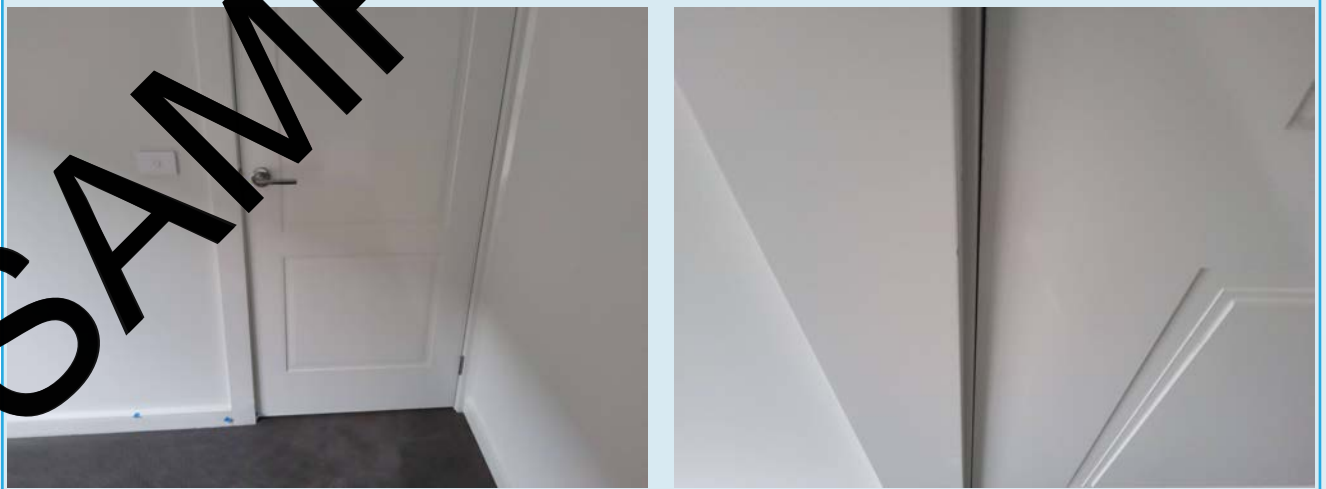
It has been observed that the door margin on the left hand side of the door appears to be tight, less than 2 mm.

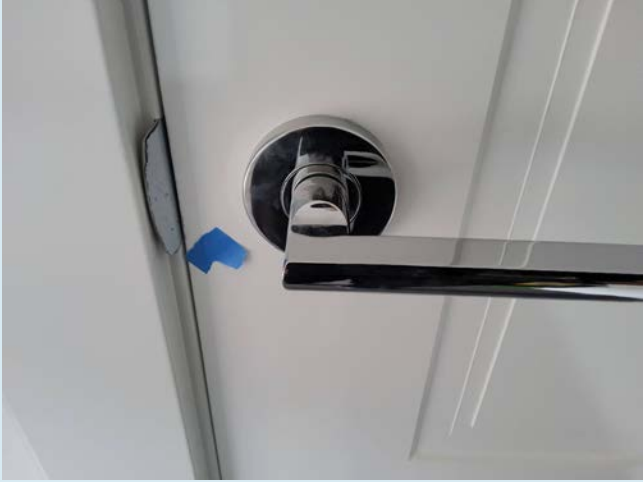
Bedroom 2	
Minor and/or Major Defect	Doors
<b>Comments</b>	
It has been observed that the latch appears not to engage with the striker plate.

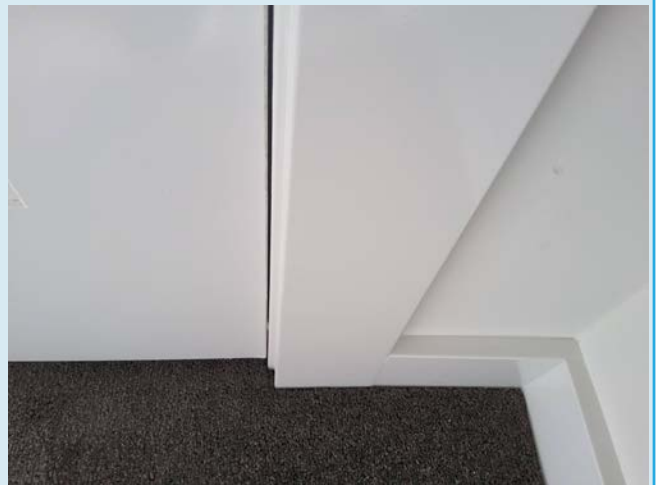
<b>Bedroom 3</b>	
<b>Minor and/or Major Defect</b>	Doors
<b>Comments</b>	
It has been observed that the door margin on the bottom right hand side of the door appears to be tight, less than 2 mm.

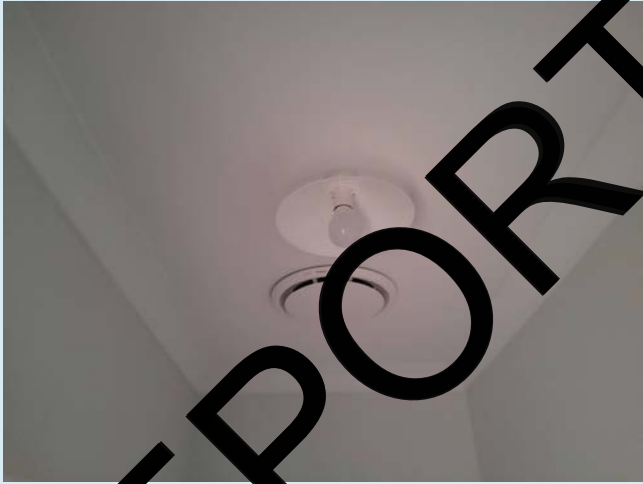
<b>Bathroom 1</b>	
Minor and/or Major Defect	Ceilings
<b>Comments</b>	
WC, it has been observed that the light switch appears not to engage the light and or the exhaust fan.

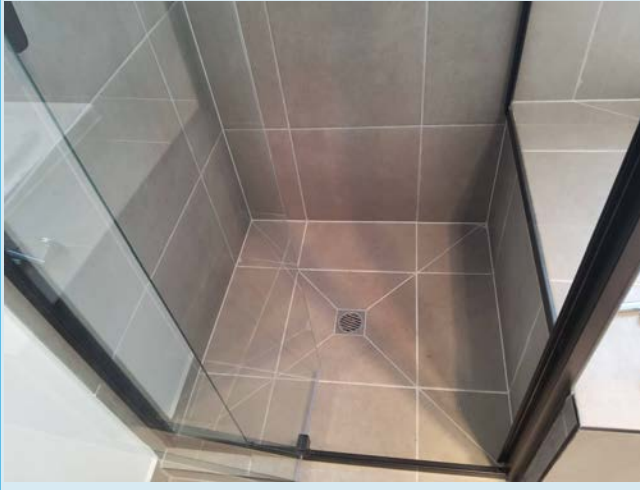
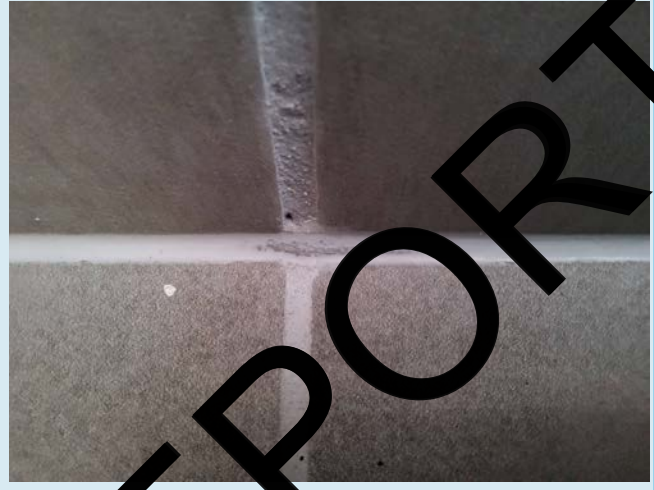
<b>Bathroom 1</b>	
<b>Minor and/or Major Defect</b>	<b>Sealants</b>
<b>Comments</b>	
It has been observed the caulking to the perimeter of the shower base appears to be contaminated with tile glue.

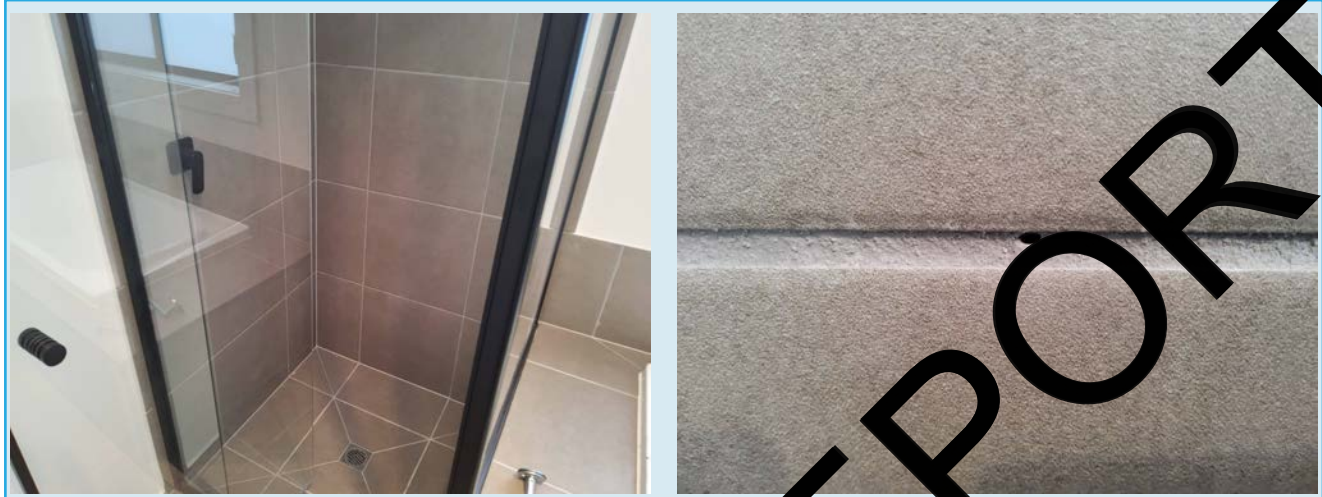
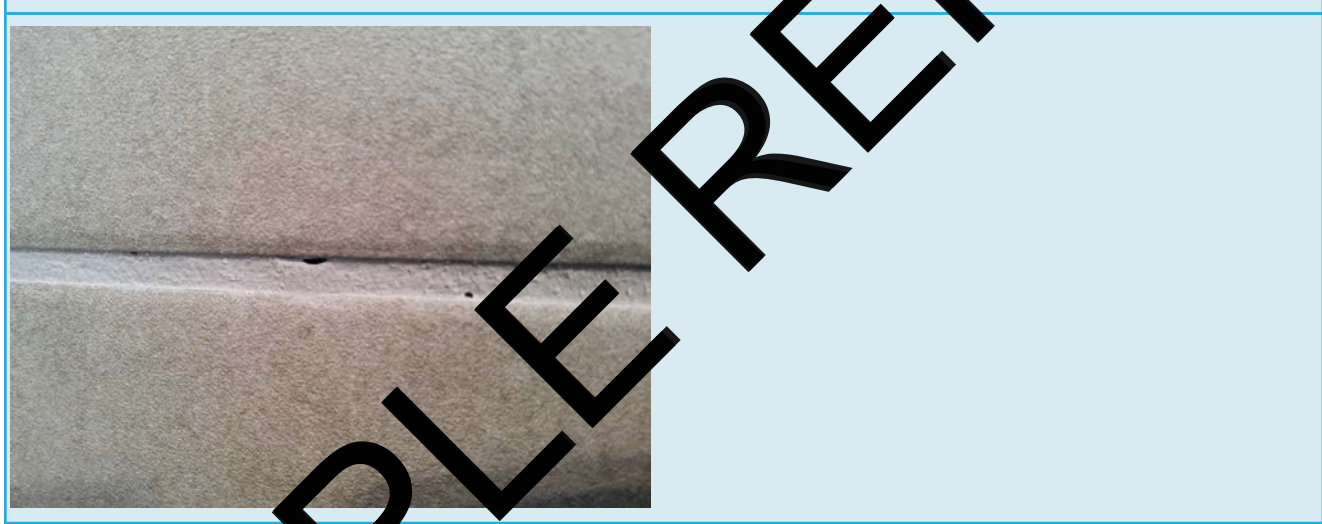
Check throughout, it has been observed that there appear to be a number of pinholes to the tile grouting that will need to be rectified.

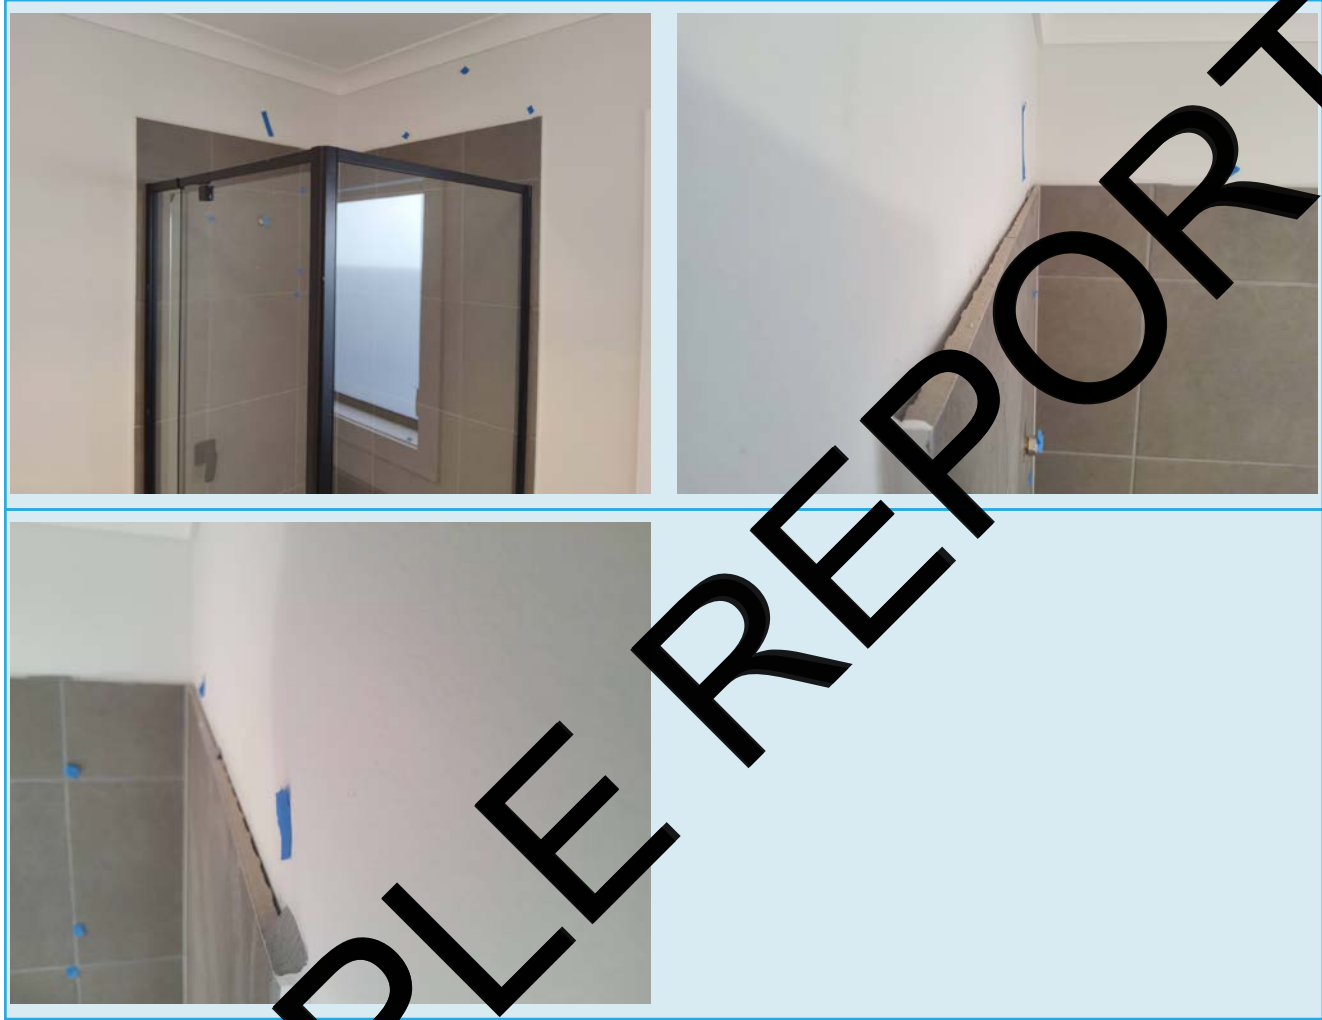
It has been observed that there appears to be gaps to the top edge of the tiles in the shower recess area, the gaps will need to be filled in.

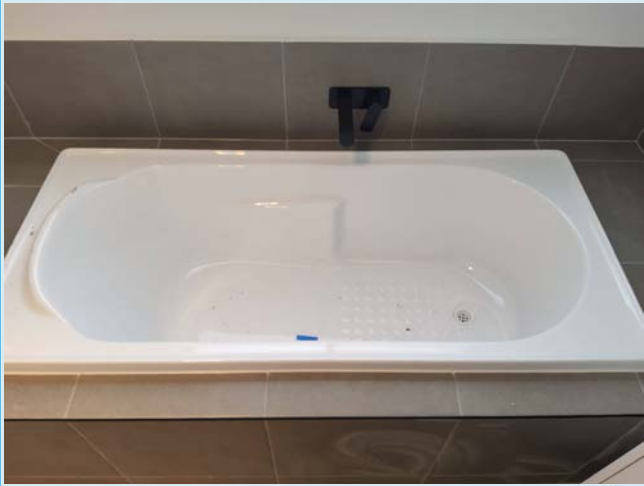
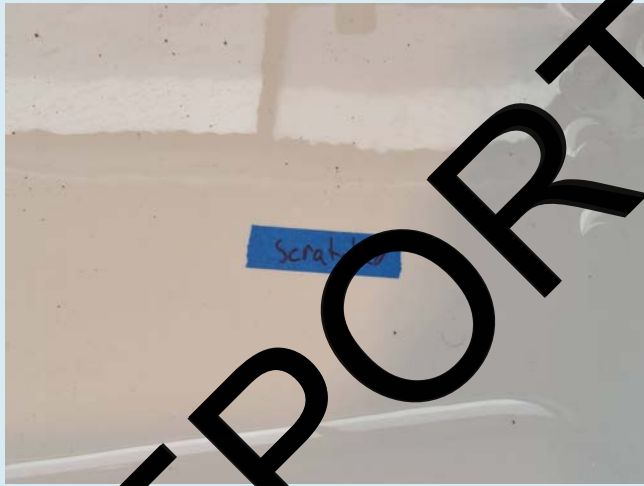
<b>Bathroom 1</b>	
<b>Minor and/or Major Defect</b>	<b>Bath</b>
<b>Comments</b>	
It has been observed that the bathtub appears to be scratched to various areas.

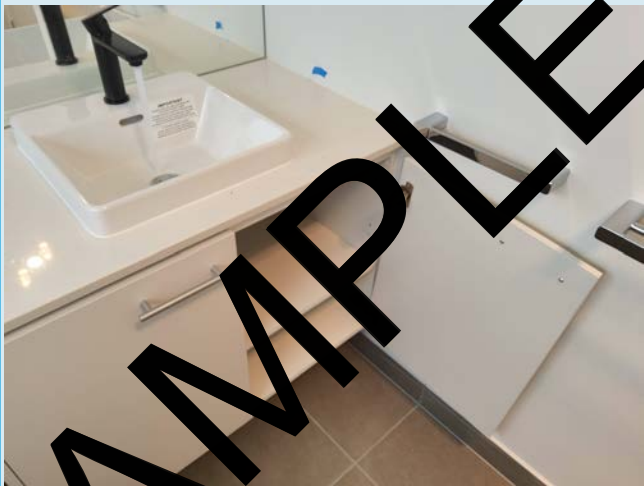
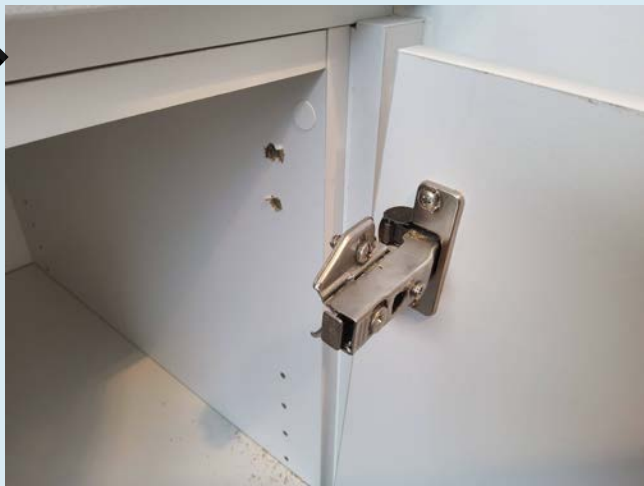
<b>Bathroom 1</b>	
<b>Minor and/or Major Defect</b>	<b>Cabinet</b>
<b>Comments</b>	
It has been observed that the top right hand side door hinge appears to have become separated from the cabinet.

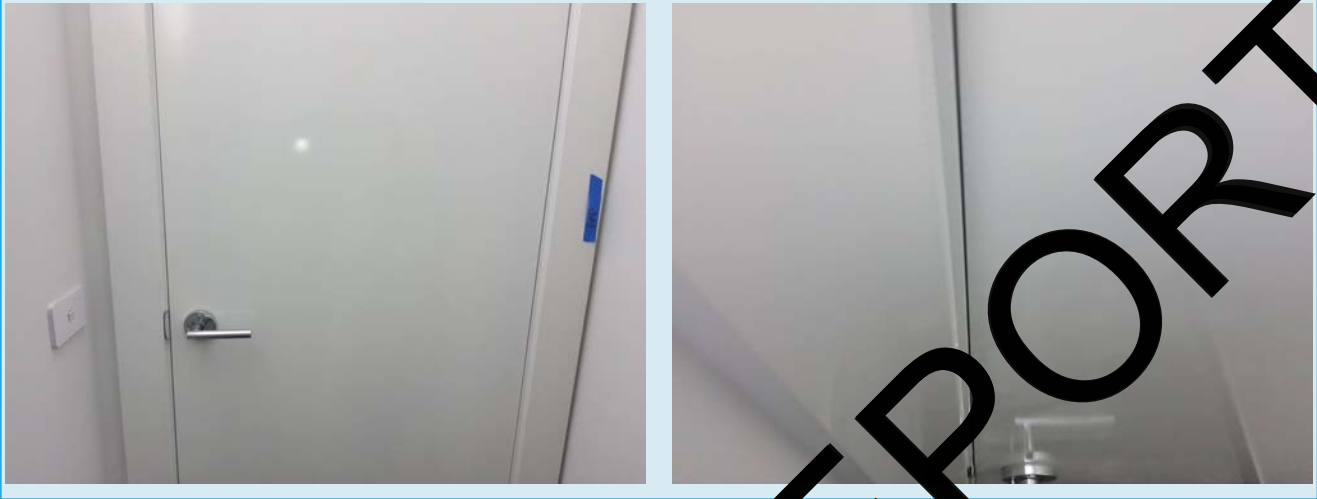
<b>Bathroom 1</b>	
<b>Minor and/or Major Defect</b>	<b>Doors</b>
<b>Comments</b>	
WC, it has been observed that the door margins to the left-hand side of the door appear to be tight, less than 2 mm.

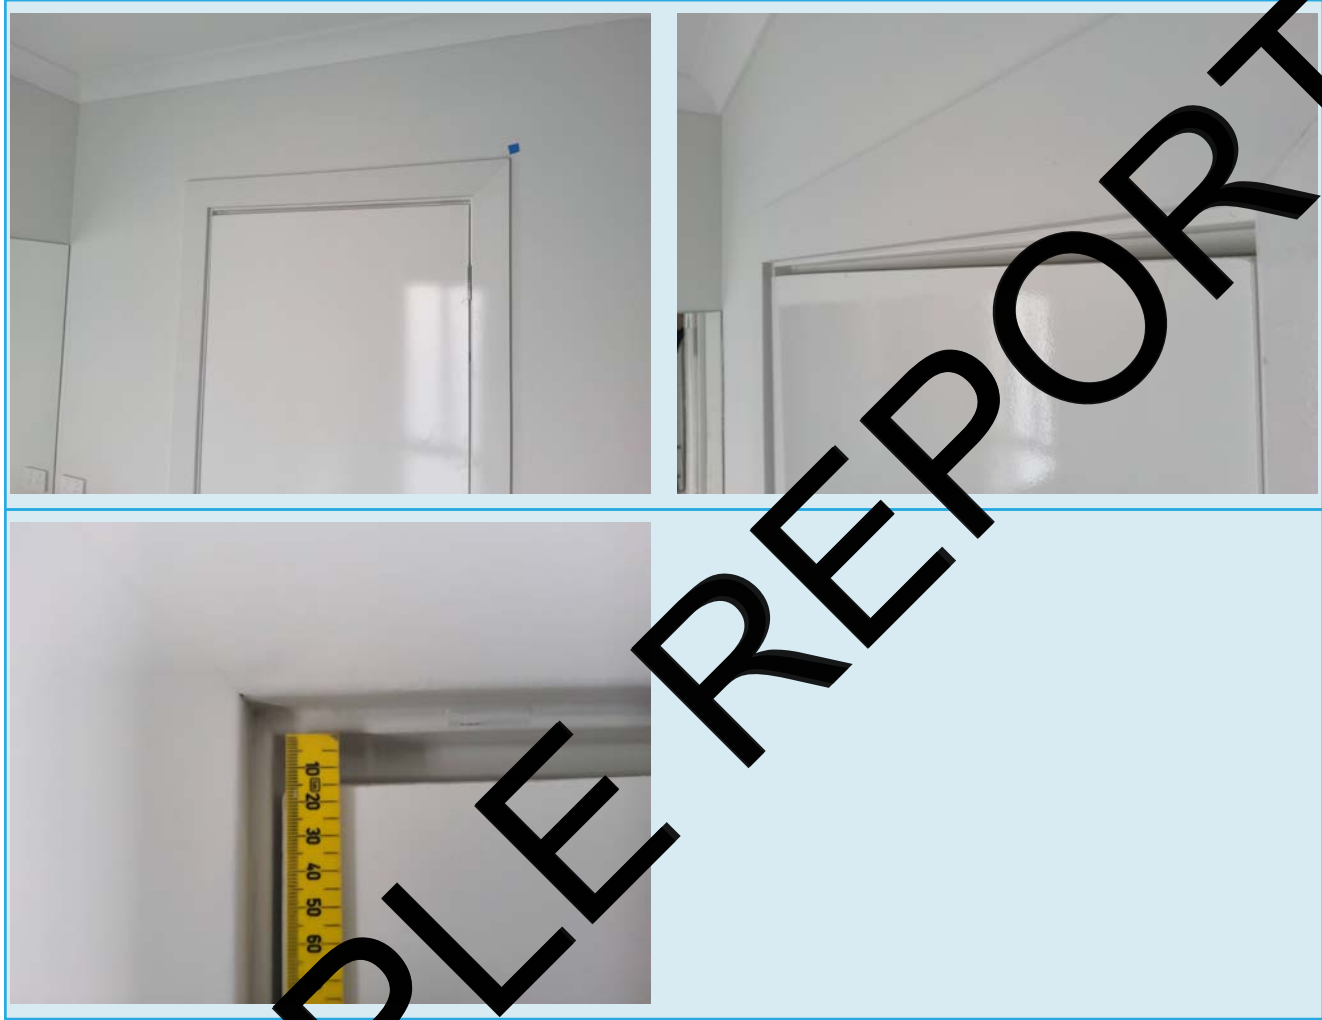
It has been observed that the door gap for the lift off hinges appears to be excessive, the gap should be 10-12 mm, also the top of the door has not been cut straight.

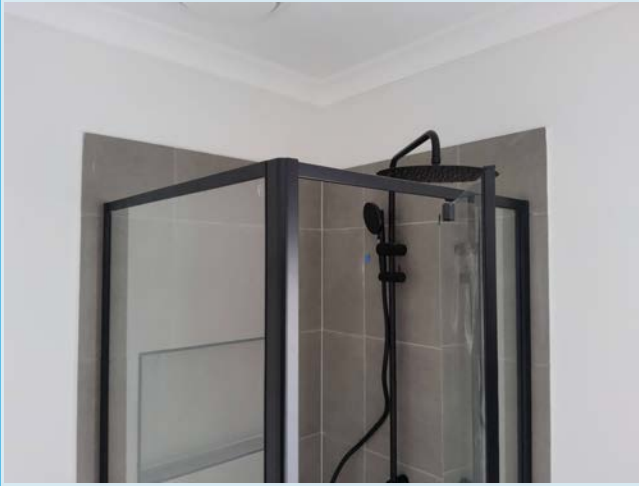
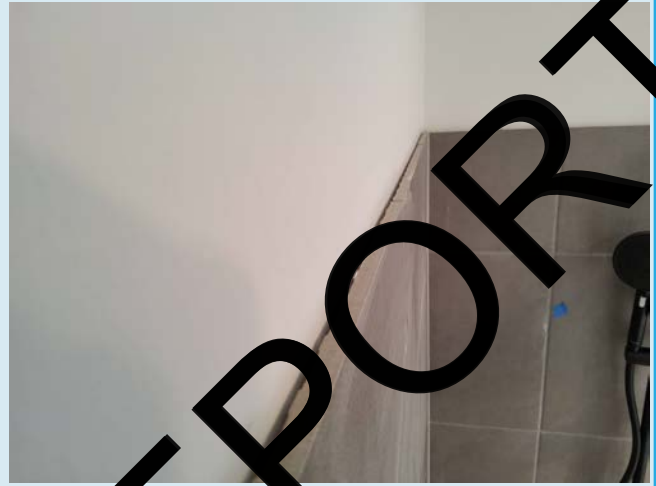
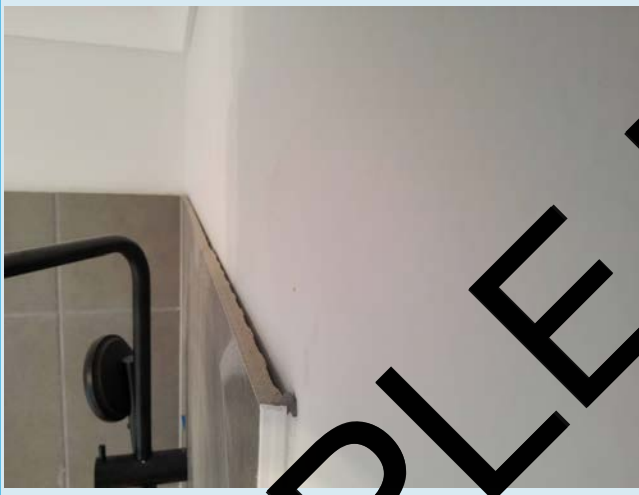
It has been observed that there appears to be gaps to the top edge of the tiles in the shower recess area, the gaps will need to be filled in.

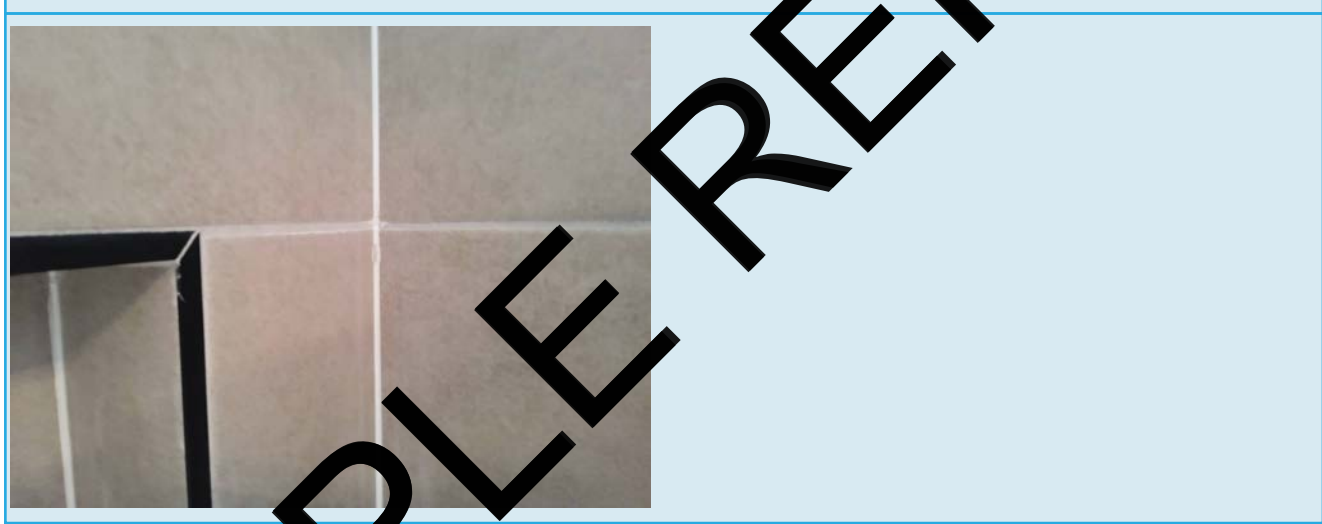
It has been observed that the caulking appears to be contaminated with tile glue, adjacent to the top right hand corner of the niche.

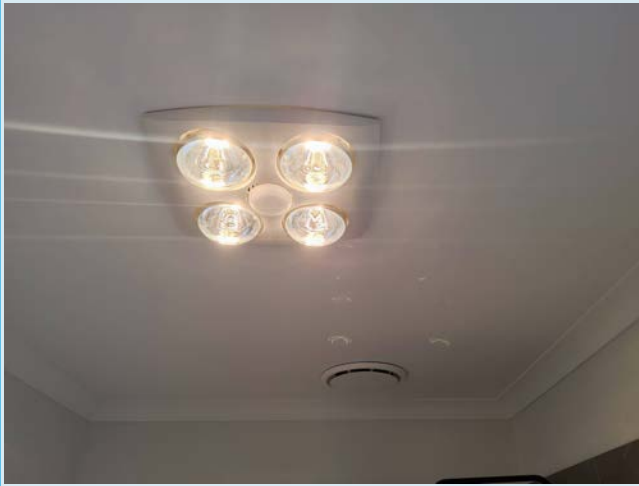
It has been observed when switching on the heat lamps for the IXL the exhaust fan also appears to engage.

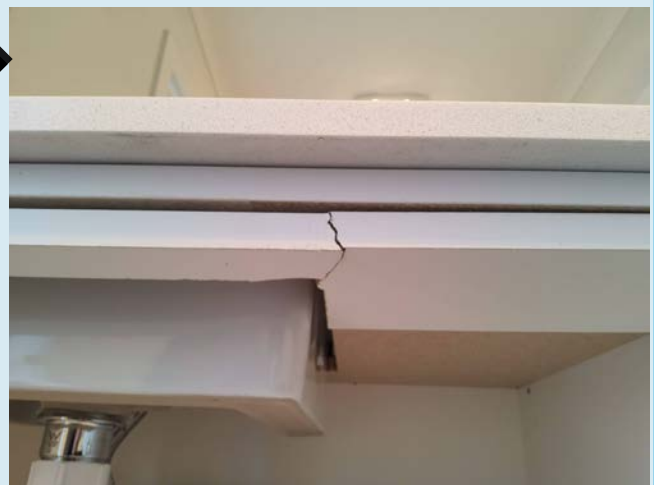
It has been observed that the cabinet below the left hand side basin appears to be cracked.

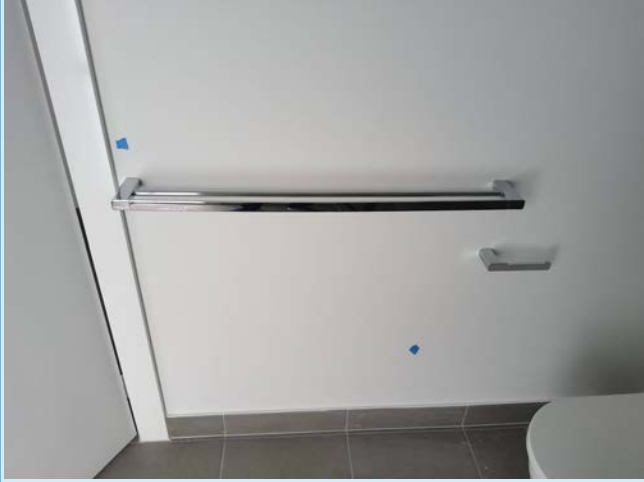
<b>Ensuite 1</b>	
<b>Minor and/or Major Defect</b>	<b>Walls</b>
<b>Comments</b>	
Confirmation of towel rail size requested, the provided elevation depicts a shorter towel rail than the one that has been installed.

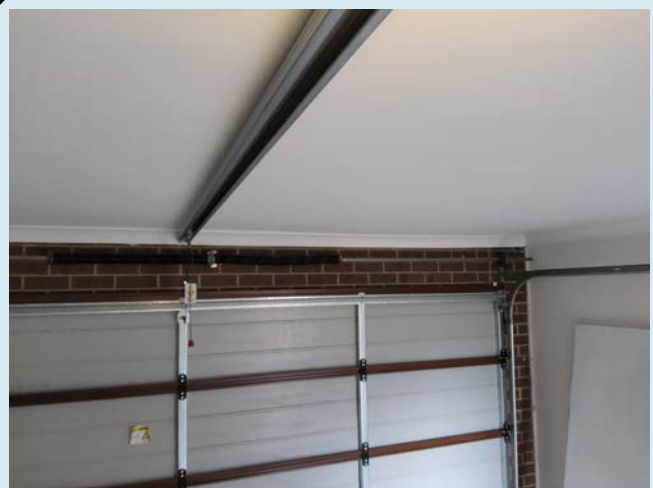
Garage, front elevation, it has been observed that the ceiling/cornice line appears to be bowed.

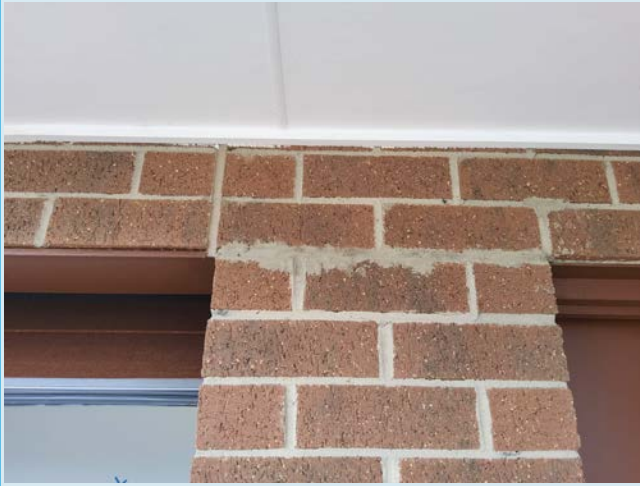
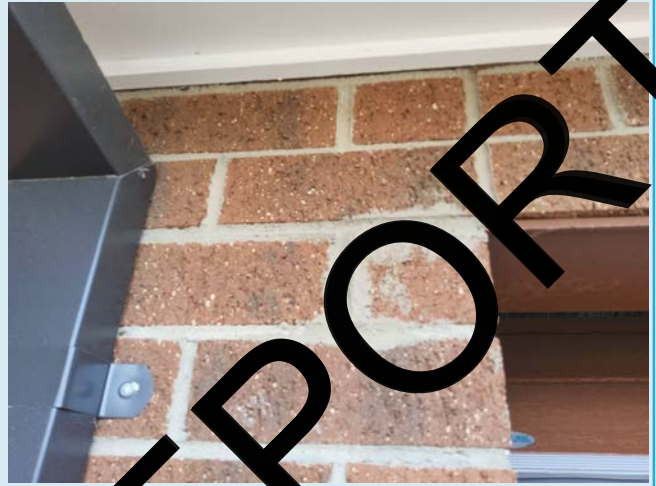
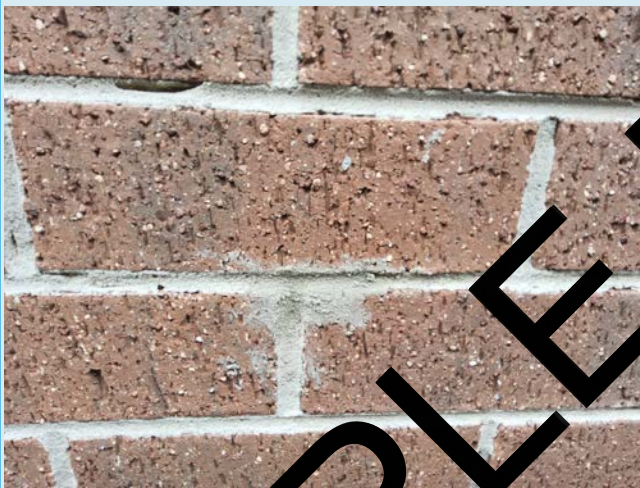
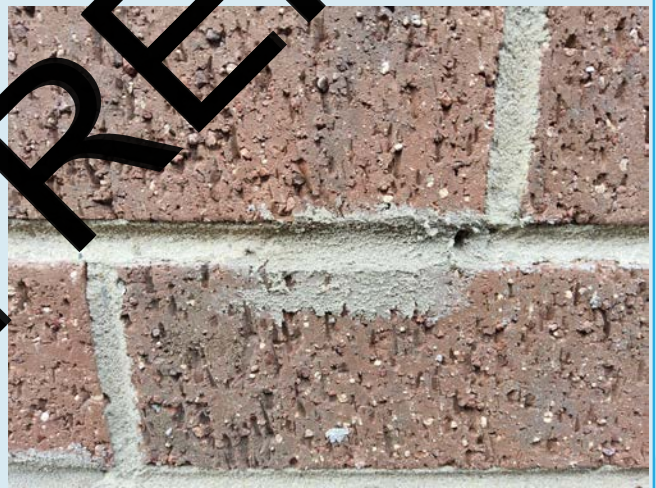
General note, check throughout, it has been observed that there appear to be mortar smears to various areas of the brickwork throughout the home that will need to be cleaned off.

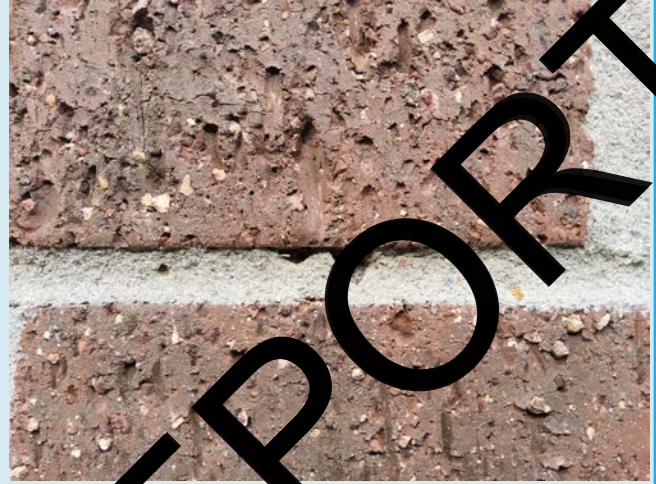
General note, check throughout, it has been observed that there appear to be gaps/holes to the brick mortar that will need to be filled in.

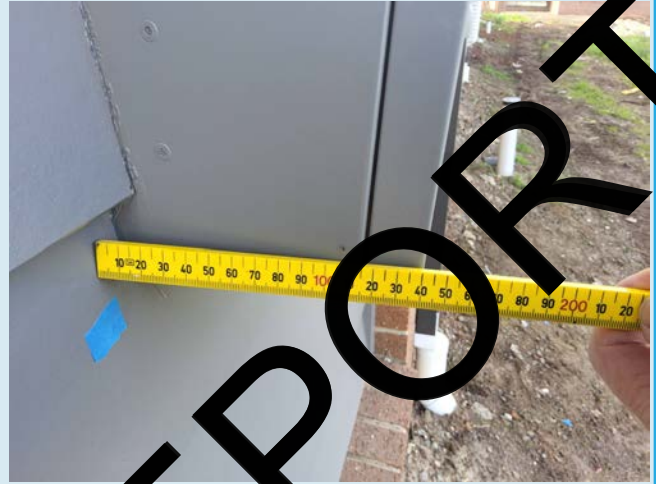
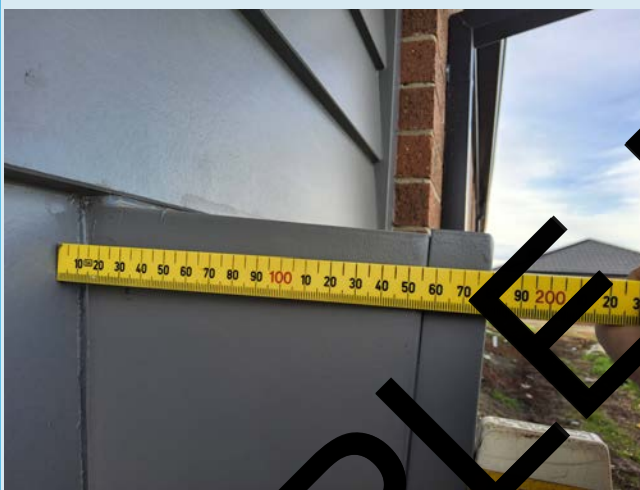
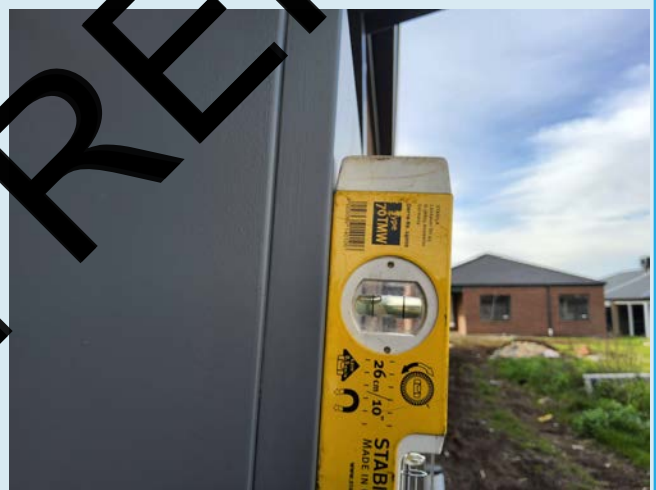
Right elevation, it has been observed that the meter box appears to have been installed out of plumb.
